Cobra Communications

# TECHNICAL BULLETIN

## Number 1226

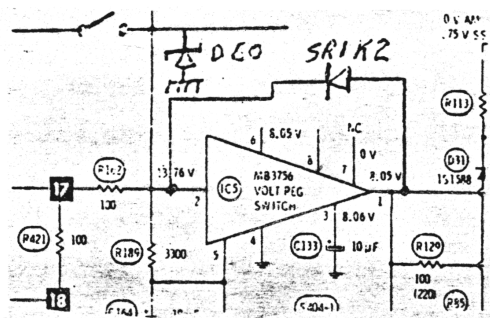
- TO:** ALL COBRA WARRANTY STATIONS  
MODEL 140GTL - 142GTL - 148GTL.
- SUBJECT:** REGULATOR IC SHORTING OUT IN THE 140GTL, 142GTL, AND 148GTL. IC-5 (140, 142GTL), IC-4 (148GTL).
- SYMPTON:** HIGH AM POWER OUTPUT (10 WATTS) AND LOW MODULATION WEAK OR NO RECEIVE.
- SOLUTION:** REPLACE IC-5 (IC-4 FOR 148GTL) AND CHANGE D-60 (D-44 FOR 148GTL) TO A 18.2 VOLT ZENER DIODE. ADD A SR1K2 DIODE FROM PIN 1 TO PIN 2 OF IC-5 (IC-4 FOR 148GTL). (USE DIODE REMOVED FROM D-60/44).
- ADJUSTMENTS:** NONE REQUIRED.

DYNASCAN PART NOS. SR1K2 151-045-9-001  
SUB. 16.2 VOLT ZENER 152-057-9-001. 18.2 VOLT ZENER (P/N N.A. AS YET)  
TO BE USED WHEN IN STOCK

**NOTE:** THIS MODIFICATION SHOULD BE DONE ON ALL RADIO'S IN FOR IN-WARRANTY REPAIR. IF IC-5 (IC-4) CHECKS GOOD, ONLY MAKE DIODE CHANGES.
