1297

October 11, 1988

TO : COBRA CB WARRANTY STATIONS

MODELS AFFECTED : 19 Plus A (19 Plus, S/N 80809883 to 80915252)

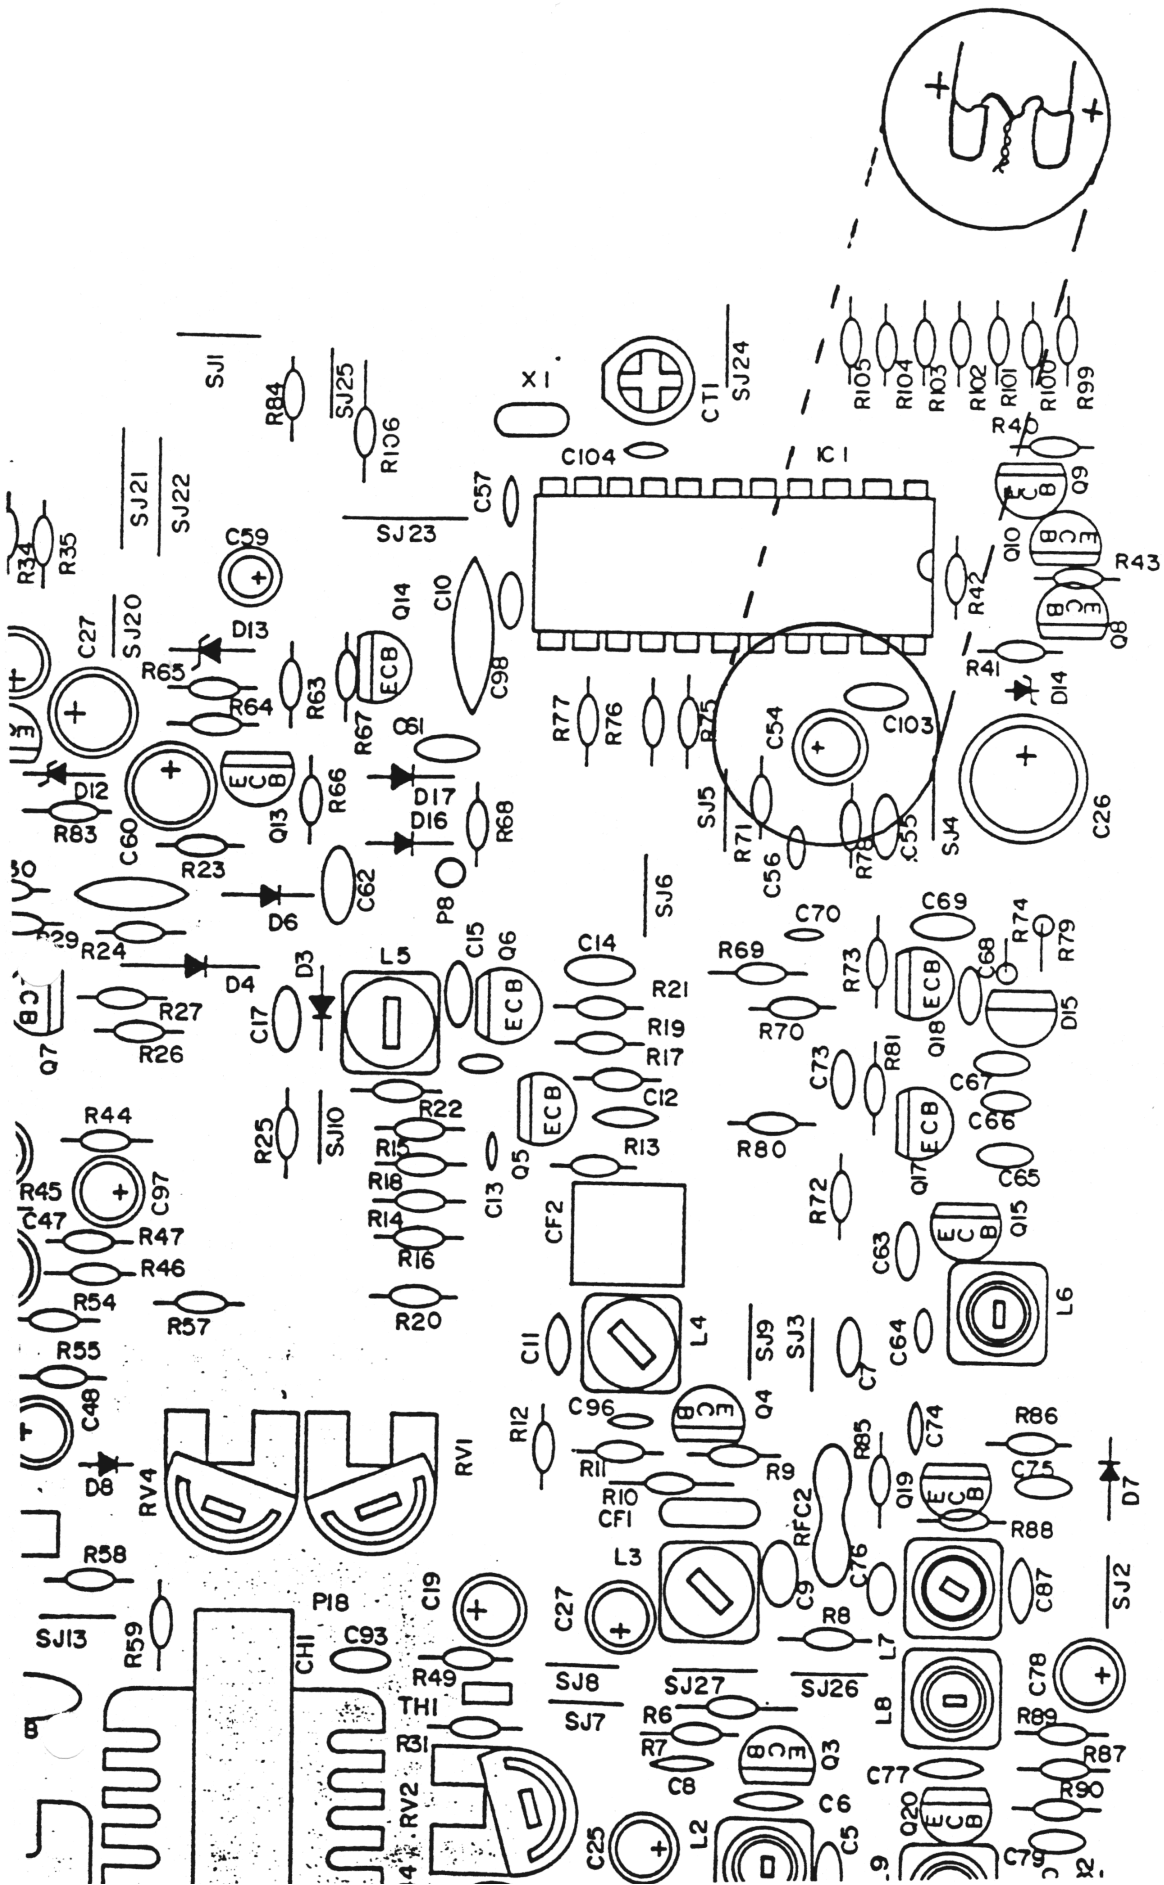
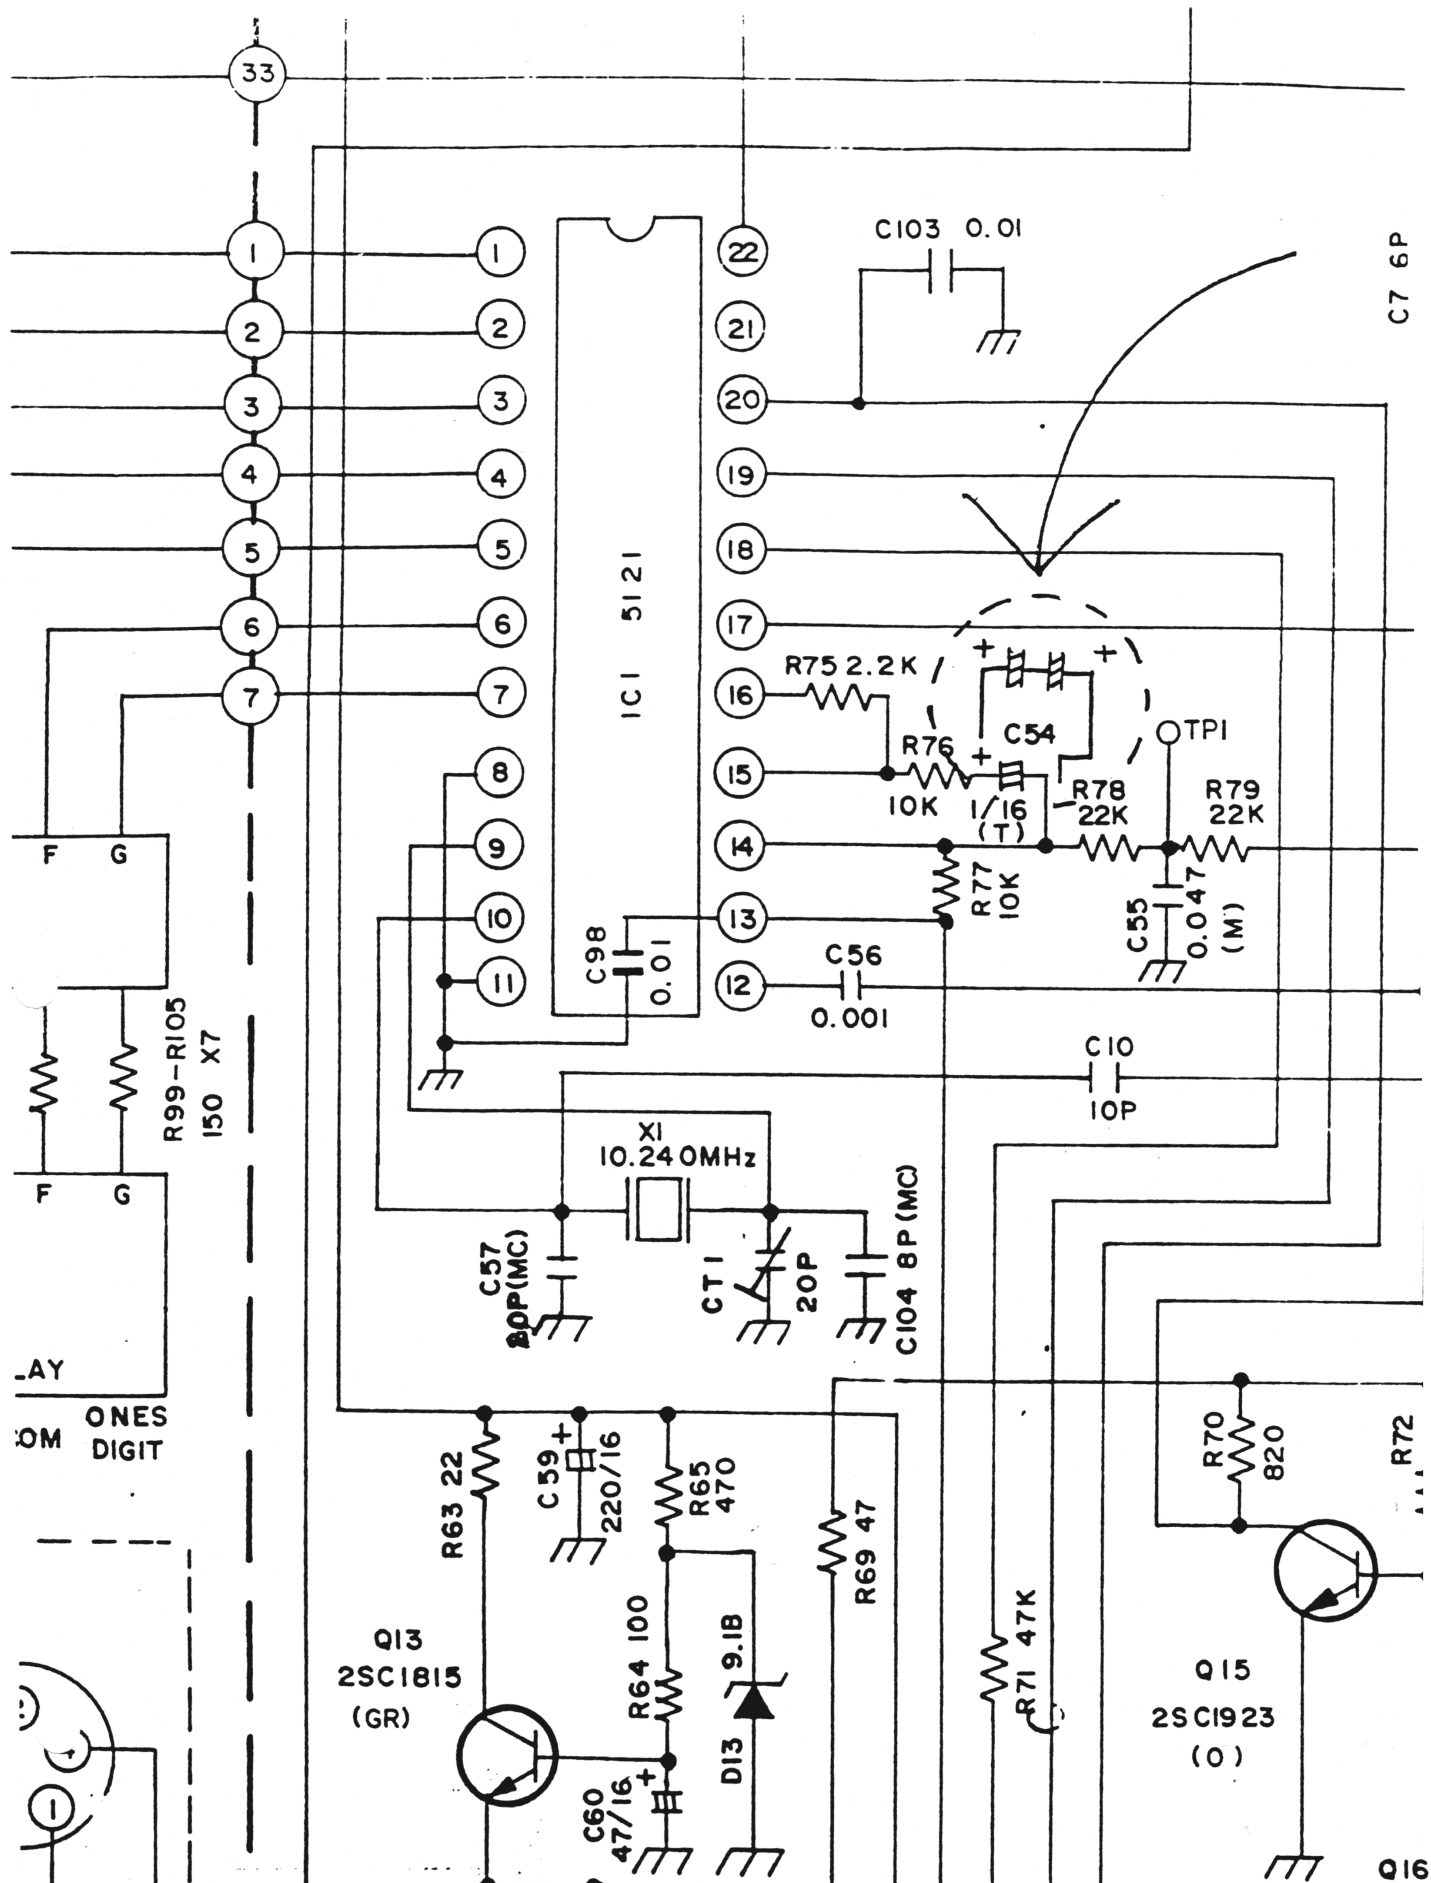
SYMPTOMS : All 19 Plus A units received for service should be modified regardless of customer complaint.

ACTION : Replace C54 with (2) 1uF, 16V tantalum capacitors in series (Non-Polar).

DETAILS OF CHANGE : 1. Locate and remove C54 (see attached illustrations). Discard this capacitor.

2. Prepare the two new capacitors by twisting together their negative leads and soldering.

3. Insert the finished capacitor pair in place of C54 such that one positive lead of each capacitor replaces the original C54 (net result is a non polar capacitor. Positive leads to circuit). Solder in place.

ALIGNMENT REQUIRED: Verify proper VCO alignment. Follow attached VCO alignment procedure, adjusting L6 as necessary.

1. Connect Voltmeter to TP 1 (junction of R78, R79 and C55)
2. With unit in receive mode on channel 1, adjust dc voltage at TP 1 to 1.5 volts using L6.
3. Check for proper operation on channels 1 and 40, RX and TX.
4. Disconnect voltmeter.
