Icom IC-706MKIIG 15/17 Meter Instability Fix  
Phil Salas – AD5X

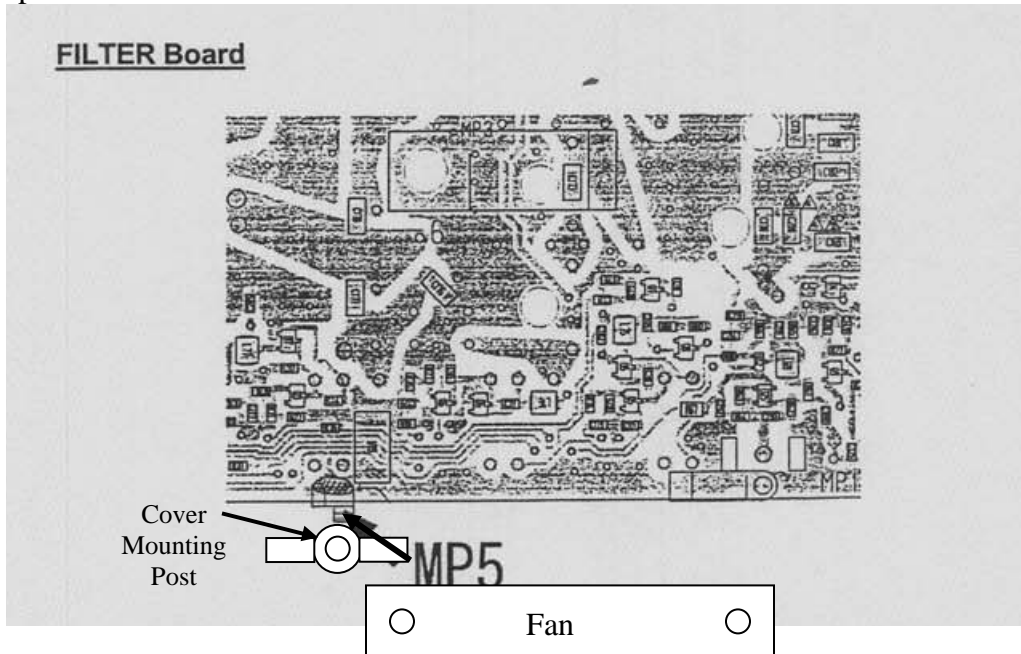
Some IC-706MKIIG transceivers experience instability problems on 15- and 17-meters, generally when the SWR is above 2:1. Icom recognized this and put out Service Bulletin #928 which addresses this problem by having you solder a ground spring (MP5) to a specific location on the filter board as shown below.
